## OoB issue found in HiOS 09.4.01 for GRS1040

Christoph Strauss - 2023-09-20 - HiOS

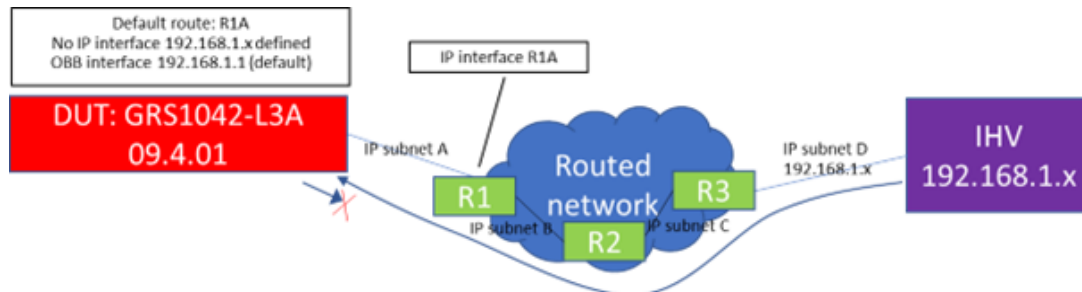
If a GRS1040 is used in an L3 environment it will not send out packets to destination subnet where the out-of-band (OOB) interface is member of.

The GRS was configured correctly with a default route pointing to the next interface of router R1. Default IP address is configured for the OOB interface (192.168.1.1) and no changes were made for this interface.

Even if no cable is connected to the OOB port the GRS uses the IP address of the OOB interface for routing decisions and will therefore not send out packets for this subnet towards the default gateway. Therefore, the IHV management station does not get packets from the DUT and the DUT will be unreachable.

This is a kind of normal behavior for a router, **but it was different for HiOS versions < 09.1.00** based on VxWorks.

Please configure the OOB interface to an IP address where the subnet is not used in the network at all. Please do this configuration **prior to an update to 09.4.01** from a version < 09.1.00.

- R&D will provide a change in an upcoming version.
