OoB issue found in HiOS 09.4.01 for GRS1040

Christoph Strauss - 2023-09-20 - HiOS

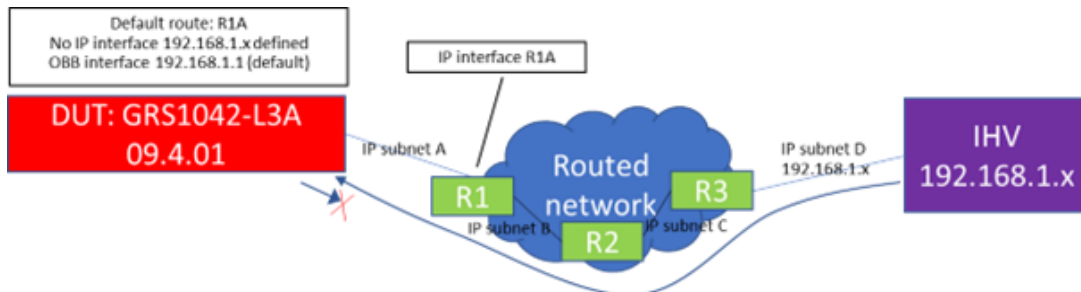
If a GRS1040 is used in an L3 environment it will not send out packets to destination subnet where the out-of-band (OOB) interface is member of.

The GRS was configured correctly with a default route pointing to the next interface of router R1. Default IP address is configured for the OOB interface (192.168.1.1) and no changes were made for this interface.

Even if no cable is connected to the OOB port the GRS uses the IP address of the OOB interface for routing decisions and will therefore not send out packets for this subnet towards the default gateway. Therefore, the IHV management station does not get packets from the DUT and the DUT will be unreachable.

This is a kind of normal behavior for a router, **but it was different for HiOS versions < 09.1.00** based on VxWorks.

Please configure the OOB interface to an IP address where the subnet is not used in the network at all. Please do this configuration **prior to an update to 09.4.01** from a version < 09.1.00.

- R&D will provide a change in an upcoming version.
